REPORT NO: MT-09/535

TESTING OF 1300TEMPFENCE TEMPORARY POOL FENCING

CLIENT: 1300TEMPFENCE
PO BOX 330
NIDDRIE VIC 3042

DATE OF TESTING: DECEMBER 1ST – DECEMBER 4TH 2009

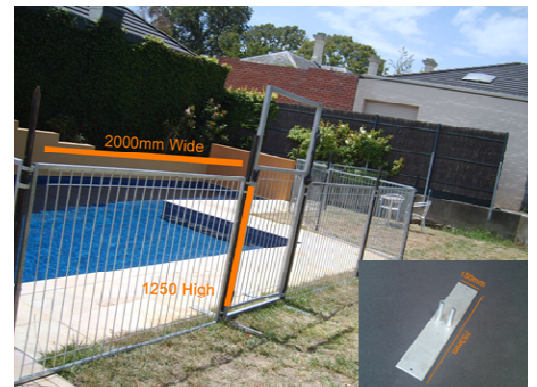
FIG.1.
TEMPORARY POOL FENCE

Temporary pool fence panels, a number of foot plates, star picket posts and gates fitted with an automatic closing device were delivered to the Melbourne Testing Services (MTS) laboratory for testing. Upon arrival at the laboratory the test items were inspected and the following fence identification details were recorded:

Fence Panels: 2.0m wide x 1.25m high

Gate Panel: 0.92m wide x 2.0m high

Fence Frame: 25mm x 25mm x 1.5mm zinc coated RHS.

Infill: Upright wire spacings: 67mm
Wire size: 8.0mm diameter horizontal bars
Wire Size: 5.0mm diameter vertical bars

Foot Plates: L=750mm, W=100mm, T=9.5mm.

Temporary pool fence panels were prepared for testing in both single panel and continuous panel configurations. Continuous panel testing was conducted on four and five panel assemblies with the gate panel located in the middle. The temporary fencing was assembled using the supplied fixtures and in accordance with the manufactures assembly guidelines.

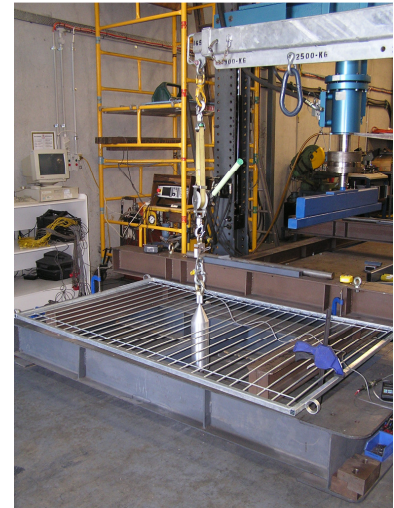
FIG.2.
FENCE OPENING STRENGTH TEST

Testing was conducted in accordance with Appendix A on a single fence panel and a gate panel to determine if the infill material had sufficient strength to prevent a forced entry opening of the vertical bars. Testing was conducted in three evenly spaced locations across the width of the panel by applying a force through a cylindrical shaped object with a conical end (see Fig.2). The pull-through force was recorded for each test location.

The 1300TempFence temporary pool fence panel and gate panel exceeded the minimum force of 150N required to pass the conical test object through the fence openings at three locations across the middle of the panels. Test deflections for each location are provided Table.1.

Test Location	Pull Through Force (N)	
	Fence Panel	Gate Panel
Left of Centre	224	340
Centre	260	262
Right of Centre	255	284

The 1300TempFence temporary pool fence panel and gate panel passed the test as required by AS 1926.1 Appendix A

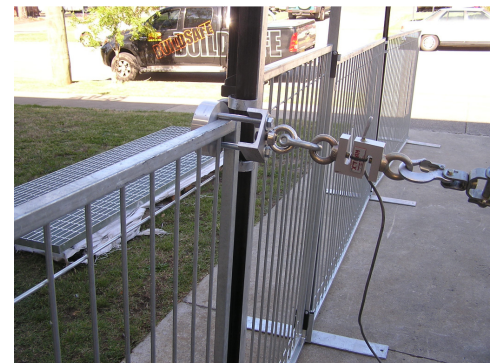
FIG.3.
STRENGTH TEST FOR POST

Testing was conducted in accordance with Appendix B on a continuous panel assembly, with two fence panels positioned either side of the gate panel. A test force of 330Newtons was applied through a cylindrical test object, as specified in AS 1926.1-2007 Fig. B1, to the top of the fence post nearest to the gate panel, in both inward and outward directions (see Fig.3). At completion of testing the fence post was inspected for signs of fracture and the gate post inspected for any damage that would prevent the gate from closing and latching. Gate panels fitted with the Easy-Fit latch and hinges were tested in the as-delivered condition and as per the client's installation. The second gate, fitted with the Magna-Latch locking mechanism and Tru-Close hinges were tested with the hinge spring tension tightened to the 2nd highest setting.

At completion of testing there was no loosening of any of the fence components or fracture of the post observed. When the load was applied from the direction of outside the pool enclosure (inward), there was no damage observed to the gate and both gates successfully closed and latched.

When the load was applied from the direction of inside the pool enclosure (outward), there was no damage observed to the gate. However, due to the angular deflection in the post, neither gate was able to self return and latch from the fully opened position.

Therefore 1300TempFence temporary pool fence panel and gate panel passed the test as required in AS 1926.1 Appendix B, for the inward loading condition only.

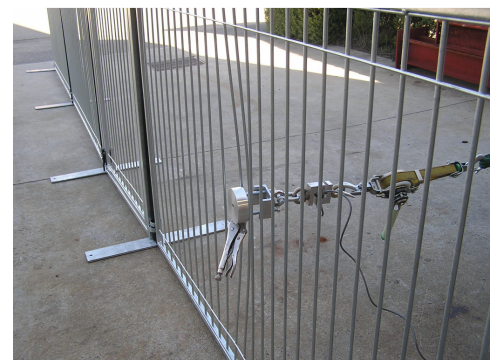
FIG.4.
INFILL STRENGTH TEST

Testing was conducted in accordance with Appendix C on a continuous panel assembly consisting of two fence panels on one side of the gate panel and three fence panels on the opposite side. The fence panel closest to the gate panel on the three panel side was the focus of testing. A test force of 250N was gradually applied to the top rail of the fence panel with any permanent deformation noted. A gradual test force of 330N was then applied with the permanent deflection recorded and inspection for breakage or loosening of components carried out upon removal of the load. The above procedure was repeated with the focus of testing being the infill section of the same fence panel (see Fig.4).

Fence Infill:

There was no permanent deflection recorded upon removal of the 250N test load.

There was 3mm of permanent deflection recorded upon removal of the 330N, less than the maximum of 10mm allowable permanent deflection. There was no loosening or failure noted in any of the fence's components.

The 1300TempFence temporary pool fence panel and gate panel passed the test as required in AS 1926.1 Appendix C
